# Corrigendum: Enhancing resilience to landslide disaster risks through rehabilitation of slide scars by local communities in Mt Elgon, Uganda

# Enhancing resilience to landslide disaster risks through rehabilitation of slide scars by local communities in Mt Elgon, Uganda

Mass movements are key drivers affecting the utilisation of many farmlands and consequently the livelihoods in mountains' ecosystems. Numerous expansive landslide scars can for years remain unusable for crop farming purposes, which is a major livelihood activity. This article examined the approaches and challenges faced by local communities in the rehabilitation of landslide-degraded areas in selected areas of Mt Elgon. Data were collected through field surveys of purposively selected scars, key informant interviews and focus group discussions with the local communities. The findings indicate that the local communities have initiated the rehabilitation of some scars to stabilise the slopes and also accelerate their quick recovery for beneficial purposes. Community trainings coupled with awareness and participatory actions during rehabilitation enhance community preparedness to landslide risks. However, there wer

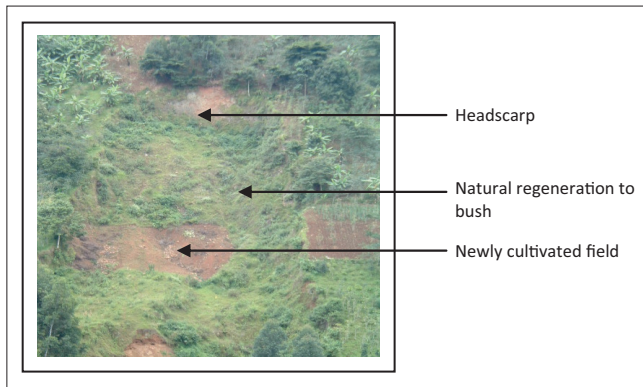
FIGURE 2: Bottle-type landslide in Bushika; 9 years after its occurrence.

The bottle slides were deep scouring (> 5 m – 15 m) and mainly occurred on upper slopes. Some of these slides changed to mudflows (bsl + ms) on the lower sections in the valleys or drainage channels because of the increase in water content in the soil mass. Most of the slides (> 90%) belong to the category of the 'bottle slides' (bsl, ms) (Figure 3) and 'sheet slides' (ss) (Table 1) according to the literature.

The majority of the scars occurred in 1997–1998, largely because of the effect of the El Nino rains, as also argued by Ngecu et al. (2004). These slides have tended to occur in the neighbourhood of the past landslides (Figure 2) on slopes of greater than 50% (for 70% of the cases observed in the field) (Figure 3). This could be explained by reduced shear stress and slope strength because of the human disturbance and slope steepness. The volume of materials, which was lost for the surveyed scars, ranged from 960 m<sup>3</sup> to 45 000 m<sup>3</sup> (Figure 3). Nearly 100% of the observed landslides occurred outside the forested areas on agricultural land dominated by banana intercropped with coffee (Figure 4).

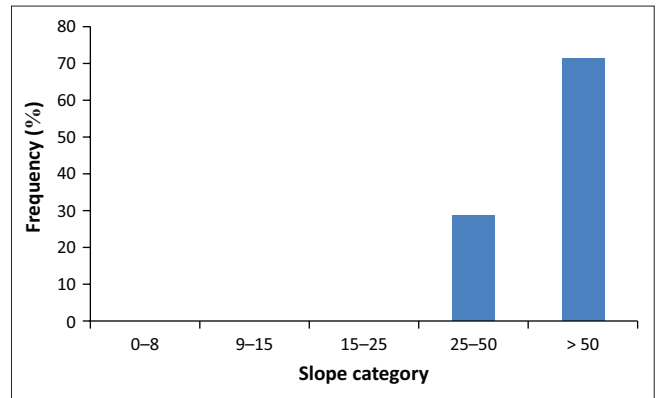
FIGURE 3: Landslide occurrence on different slopes of Bushika Subcounty.

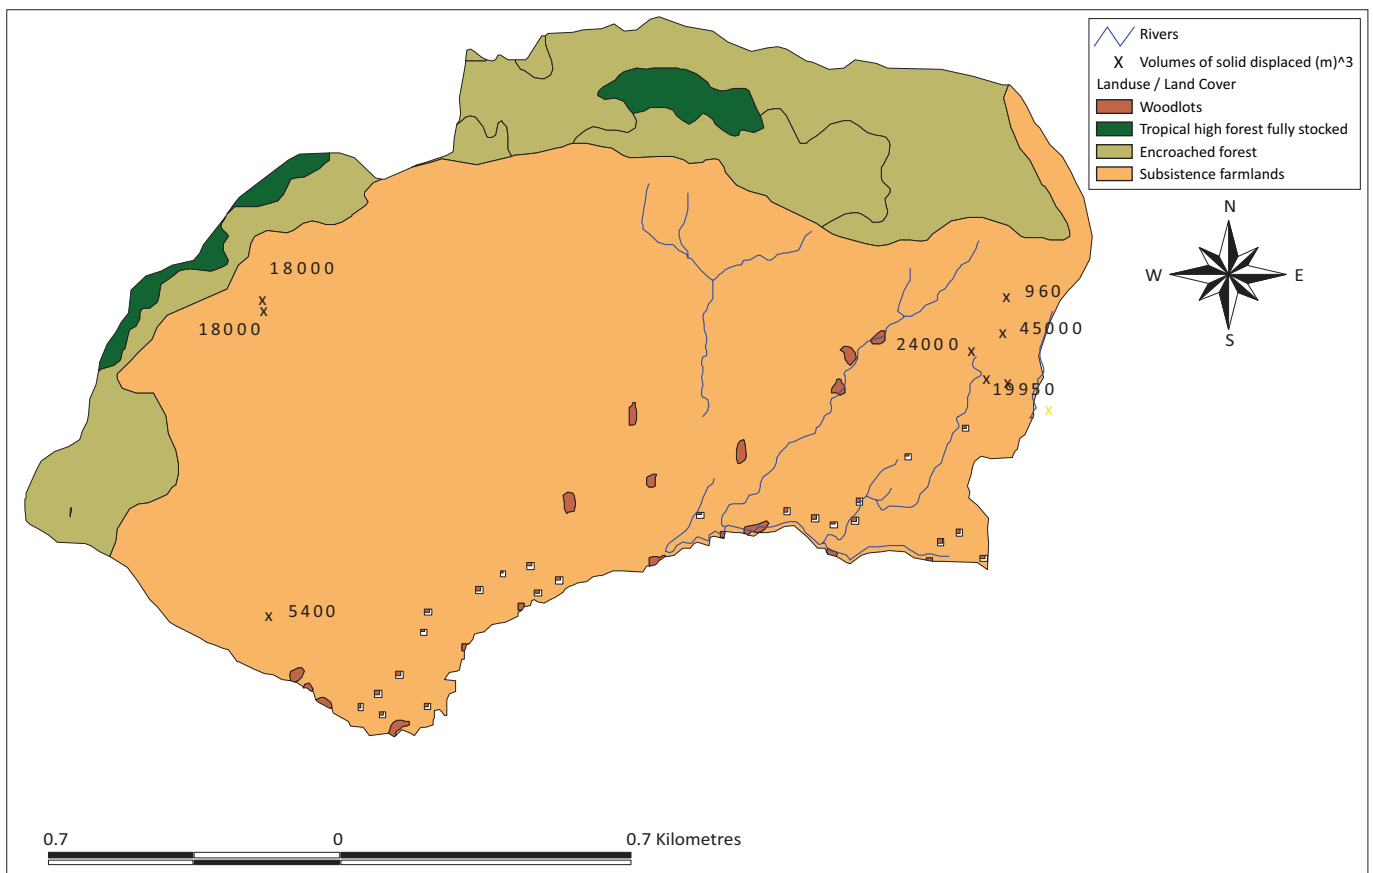
FIGURE 4: Volume (m<sup>3</sup>) of materials lost through landslide under different land use or cover in Bushika Subcounty.

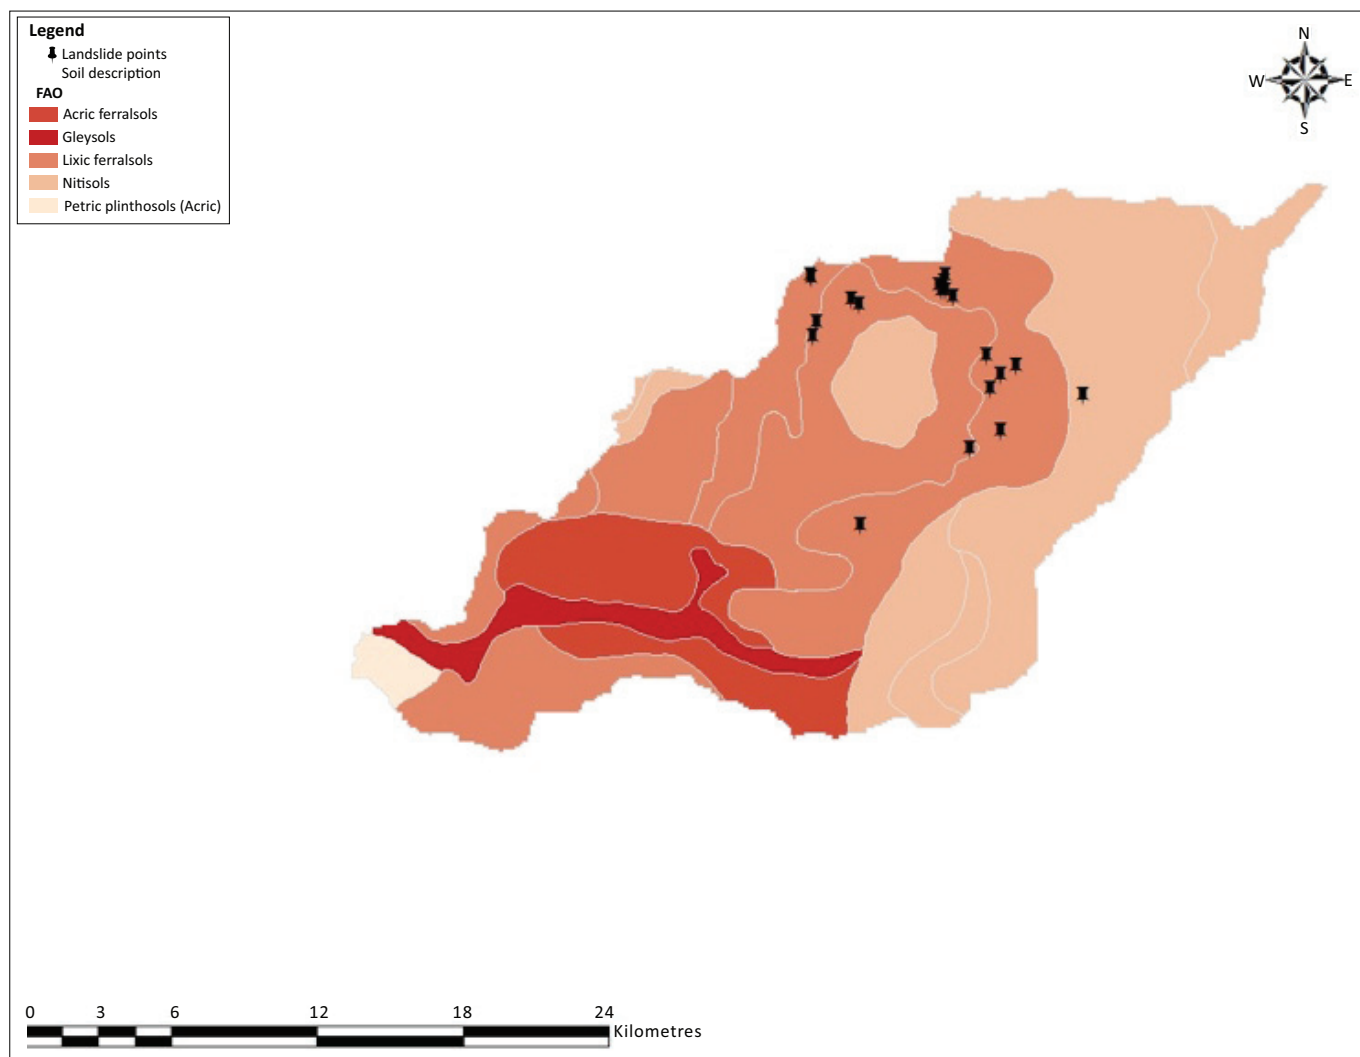
FIGURE 5: Distribution of landslide scars on different soil types in the Manafwa catchment study area.

Figure 5 shows the distribution of landslides on different soils in mid-part of Manafwa catchment in Bududa and Manafa districts. There were more slides on Haplic type of soils (red–yellow clay loams) compared with other soil types. The Haplic soil-type area also coincides with steep slopes. Kitutu et al. (2009) found that the soil type had no influence on landslides, but soil texture seems to be of significance in this zone. Studies in the southern part of the area by Mugagga et al. (2012) provide more insights into the influence of soil properties on landslides. He observed that the soils had high plasticity, water retention and low permeability. Landslides in the western zone of Bududa and, therefore, Bushika are because of soil horizon stratification that favours water stagnation in the lower horizon. That is, landslides are majorly confined to places where there is water stagnation or hydrological saturation in the lower soil horizons. Our observation of scars in this area noted the presence of streams flowing over weathered rock plane. We noted that the destruction of plant cover could have reduced the stability of soil particles and contributed to increased infiltration, hence high subterranean flows that induced slides.

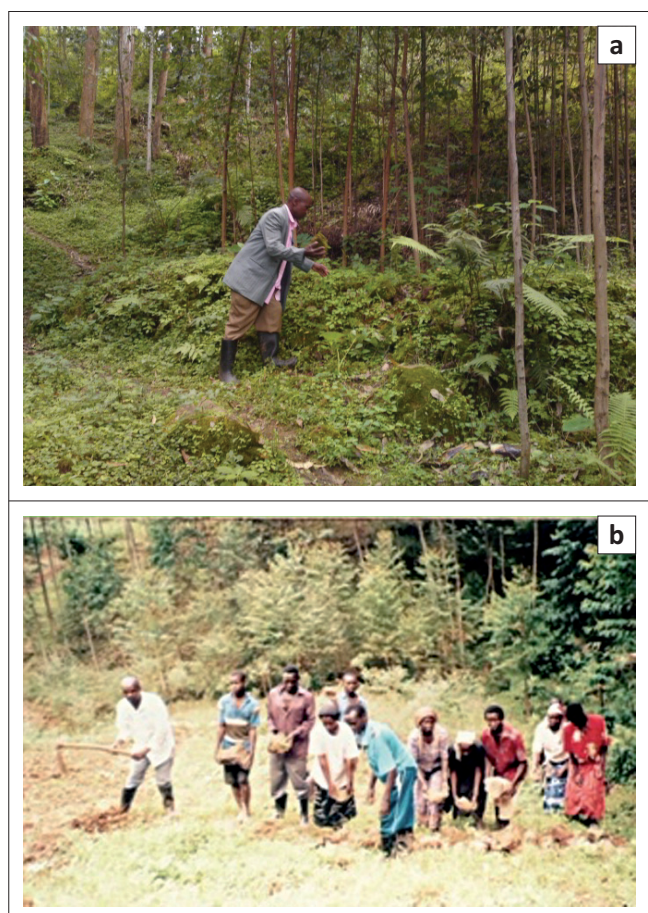
**FIGURE 6:** (a) Stone terrace (where the person is pointing) and eucalyptus trees planted to stabilise the soils on a scar in Bushika and Bunakasala villages. Note also the underground dense herbaceous growth, which is important for enhanced stability of the soil. (b) The local community members of Shunya Yettana working as a team in digging, collecting and assembling stones along a contour on the landslide scar.

- Stone bunds – Under technical advice, stone bunds were adopted by the local community on one landslide scar in Bushika to stabilise the slope hence also control erosion (Figure 6). This was perceived to have greatly controlled erosion, thus permitting revegetation growth. Stone structures have been applied elsewhere and proved to work. For instance, WOO (1992) in Korea adopted

- Agroforestry – Planting of trees such as eucalyptus (Figure 6) has been taken up by farmers on a number of scars because of fast growth rate and anticipated economic benefits. A few of the respondents who have planted eucalyptus explained that the roots penetrate deep into the soil and are therefore suitable for stabilising the soil. However, growing of eucalyptus trees has also raised questions concerning its rapid water uptake causing deficiencies for other uses. This calls for further investigations to inform decision makers. Indigenous tree species such as *Cordia africana* are recognised as useful, but they are slow in growth. *Albizia julibrissin* was reportedly being encouraged in coffee and banana-cropping system, though had not been planted on the scars. It provides shade to the coffee beside leaf litter for enriching soil organic manure. Though not measured in this study because of limited resources, literature reveals that tree roots enhance soil shear strength when the root network penetrates a potential failure surface. High tensile root force contributes to a potential slide mass that should increase with increasing area of root intersection (Roering et al. 2003). Trees contribute to landslide rehabilitation as also noted by Kervyn et al. (2015) but have some limitations. In a policy brief by Food and Agricultural Organisation (FAO), it is noted that trees reduce landslide risks by lowering the soil moisture levels through interception, evaporation and transpiration mechanism. However, it was further noted that trees could also increase landslide risks by imposing overload on unstable slopes and via wind-related effects. Trees are, therefore, unlikely to prevent or minimise deep landslides on very steep slopes. Further research focussed on this should be of great significance. On slopes undergoing restoration, management of hydrological processes is also fundamental for the success of a soil bioengineering structure and vegetation establishment (Stokes et al. 2014).

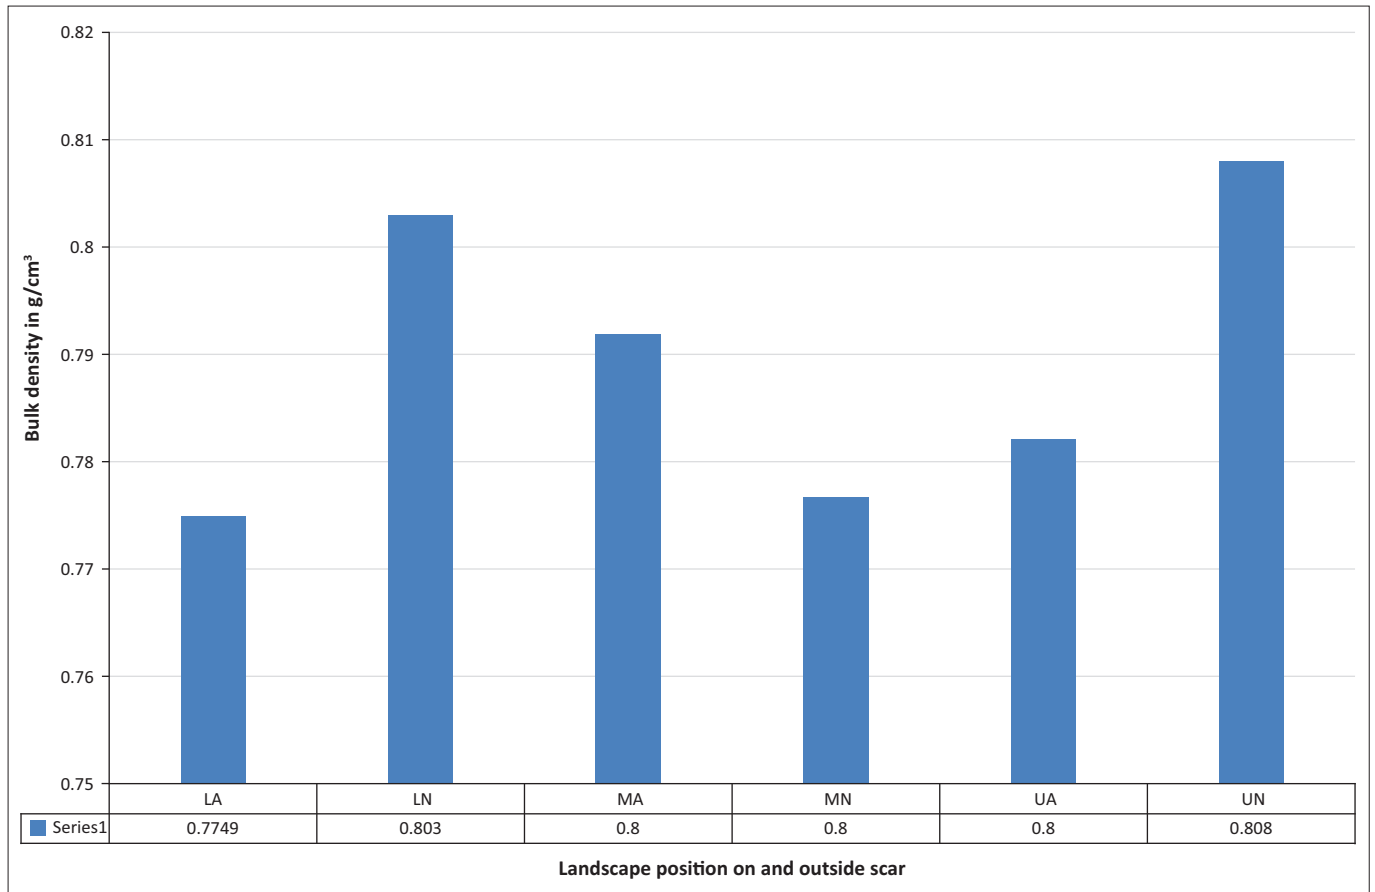
Landscape position on scar: LA, Lower inside scar, LN, Lower outside scar; MA, Middle inside scar; Middle Outside scar; UA, Upper inside scar; UN, Upper outside scar.

**FIGURE 7:** Bulk density of the top soil layer in the landslide-prone area of Mt Elgon.

The implication of this is that in the non-landslide-affected areas the flow of water is quasi-uniform across the soil profile, whereas in the landslide-affected areas water pressure builds up on top of clay layer because of its lower permeability. This is in line with observation made by Kitutu (2010) and Mugagga et al. (2012) in the same region. Bizimana and Sonmez (2015) also noted that high plasticity clay soils contribute to landslides. Apart from the influence of soils, topographic and geologic features as controlling factors for slope instability, the most common landslide triggers are intense rainfall events (e.g. Bizimana & Sonmez 2015; Crosta 1998). Numerous researchers have shown the relationship between landslide occurrence and intense rainfall periods (e.g. Azzoni et al. 1992; Canuti, Focardi & Garzonio 1985; Ferrer & Ayala-Carcedo 1997; Finlay, Fell & Maguire 1997; Hoseop, Wonseok & Enuakwa 2016; Hosseini & Hosseini 2011; Kitutu 2010; Polemio & Sdao 1999; Zezere, Ferreira & Rodrigues 1999). Although steep topography has classically been viewed as the main indicator of susceptibility to rockfall and deep-seated landslides, intense rainfalls produced during wet seasons can be the triggering factor in the initiation of slope failures. Rainfall events can also produce an increase in the rate of movement on landslides.
