# Flooding, flood risks and coping strategies in urban informal residential areas: The case of Keko Machungwa, Dar es Salaam, Tanzania

This article presents findings from a study carried out in Keko Machungwa informal settlement in Dar es Salaam under the auspices of the Disaster Management Training Centre of Ardhi University, Tanzania. The settlement has experienced frequent flooding in the past five years, and this study explores the causes, risks, extent of flooding and coping strategies of residents as well as municipality and city officials. Key methods employed in capturing empirical evidence included mapping of zones by severity of flooding, interviews with households, sub-ward leaders, and municipal and city officials. Non-participant observation, primarily taking photographs, complemented these methods. Laboratory tests of water samples taken from shallow wells in the settlement were performed to establish the level of pollution. In addition, records of prevalence of water-borne diseases were gathered from a dispensary within the settlement to corroborate flooding events, water pollution and occurrence of such diseases. Findings show that flooding is contributed to by the

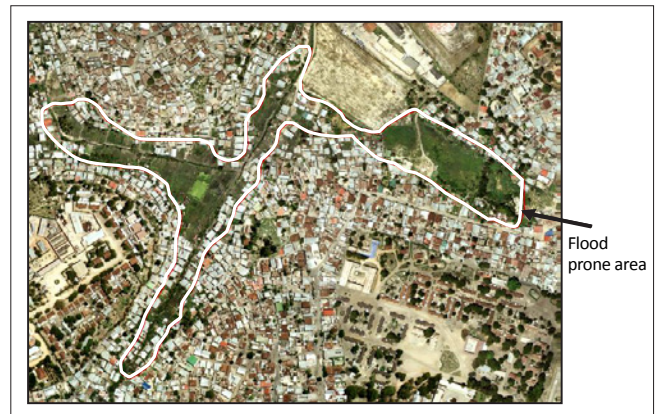
FIGURE 1: Aerial photo showing flood-prone areas.

Although about 75% of the settlement does not experience flooding, the rest of the area can be subdivided into (1) most severely flooded and (2) moderately flooded areas. The most seriously affected area of the settlement is that between one and two metres above mean sea level. A topographic analysis of the settlement showed that this area covered 5.07 hectares,

which constituted 16.37% of the total study area (see Figure 1). There were 76 houses in this area. During the peak hours of flooding water reaches a height of half to one metre above the ground floor. During the rainy season the area gets filled up with water from within and outside Keko Machungwa. The water seriously affects houses built along the valley. The area that was moderately flooded covers 2.84 hectares and lies between two and four metres above mean sea level. There were 130 houses in this area.

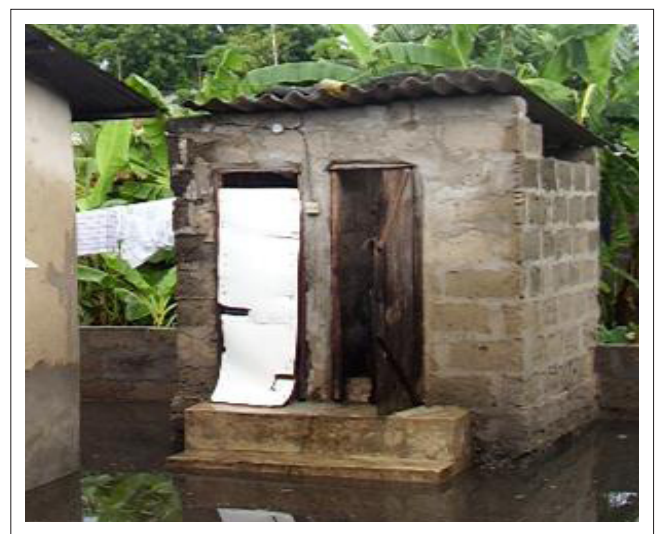
FIGURE 2: A pit latrine surrounded by stagnant water during rainfall season.

Household interviews conducted in the settlement have shown that 90% of the houses use pit latrines for sanitation. The combination of a high water table and the use of pit latrines results in frequent filling up of the pits when it rains heavily (see Figure 2).

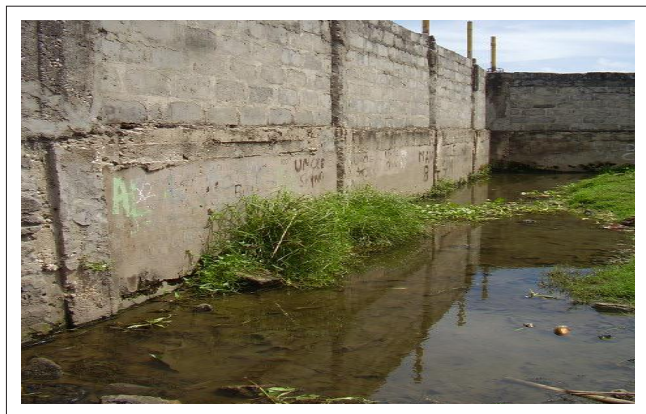
**FIGURE 3:** Wall constructed by Ruby Road Ways on top of the stream, blocking the natural course of the river.

Haphazard construction of warehouses and housing has aggravated flooding in Keko Machungwa. Examples of this phenomenon are warehouses built by Ruby Road Ways and Oil Com Company. Ruby Road Ways has constructed a warehouse across the Keko stream, leaving a small hole for stormwater. Similarly, Oil Com Company has reclaimed part of the river valley by filling up part of a plot with soil and then constructing a wall (see Figure 3).

The reclamation of land and construction of a wall necessitated shifting the river course from its original natural path towards residential areas. The partial blocking and shifting of the stream contributes substantially to flooding of the surrounding residential areas of Keko Machungwa.

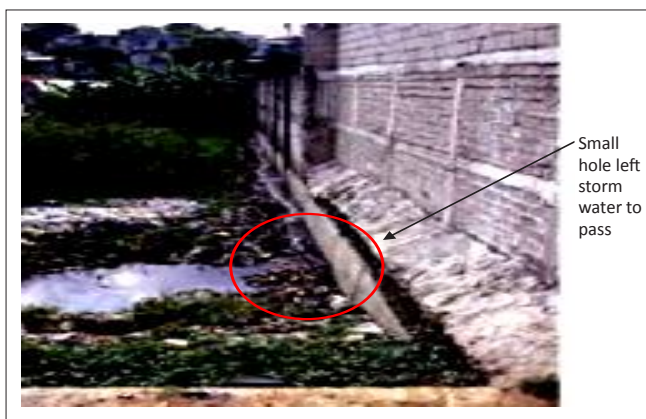
**FIGURE 4:** Wall constructed by Oil Com Company blocking natural water flow.

Although the owner of Ruby Road Ways provided a hole reinforced with some iron bars for stormwater to pass through, the size of the hole was too narrow to accommodate the huge volume of stormwater (see Figure 4).

As a result, when it rains heavily part of the stormwater flashes back to the settlement. The owner of the company explained that he had designed a small hole in order to prevent solid waste from entering his premises. In fact, when it rains heaps of uncollected solid waste accumulate and get deposited outside the wall. The accumulated waste completely blocks the hole, to the extent that stormwater can hardly pass through it. Therefore, the blocking of the natural drainage system and poor design and construction of the hole affect the majority of low-income people whose houses are in the severely flooded low-lying zone.

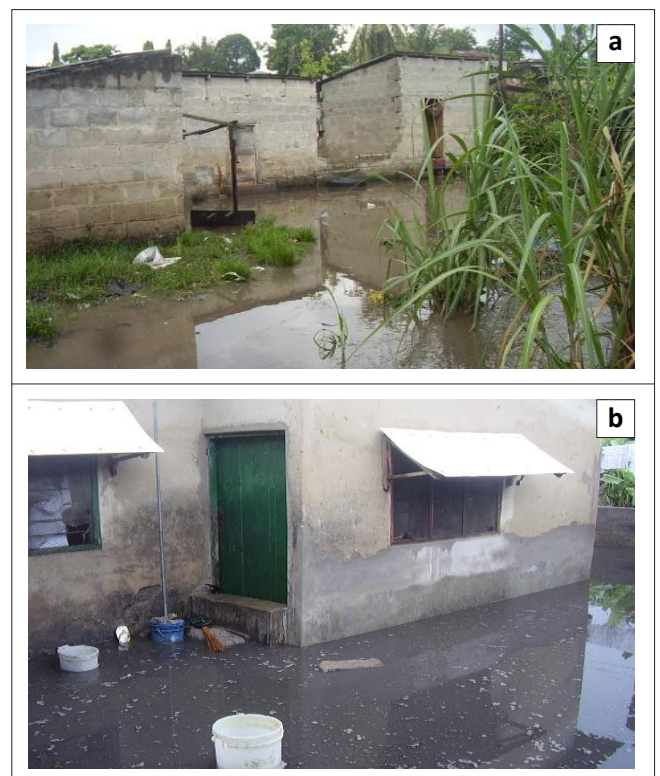
**FIGURE 5:** Waterlogging (a) and blocked accessibility (b) to houses.

It was observed that waterlogging did not only occur in the severely and moderately flooded areas but also on the flat areas with congested houses and where drainage channels were non-existent. This resulted in the blocking of both vehicular and pedestrian accessibility to these houses (see Figure 5). Some residents passed through this water barefoot, fearing destroying their shoes, this action also likely to cause diseases.

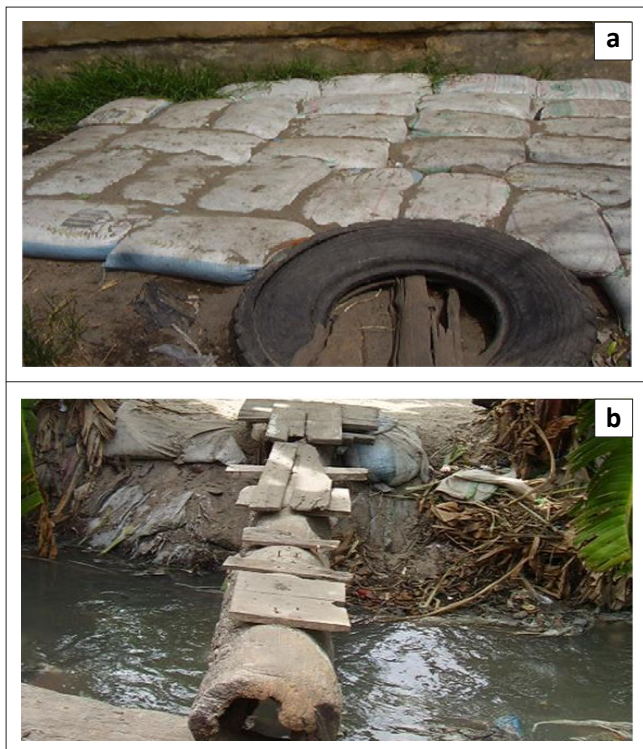
**FIGURE 6:** Sandbags (a) used to prevent flooding and erosion (b).

The use of sandbags was meant to prevent erosion, provide accessibility and block flooding water, whilst tree logs were used to construct footbridges (see Figure 6). This strategy was, however, not suitable to resist heavy stormwater from heavy rainfalls, because the sandbags and tree logs were always washed away. Of the 30 interviewed households, 24 reported having been using sandbags to prevent flooding water from entering their houses. Children and old people found it difficult to use footbridges made from tree logs.

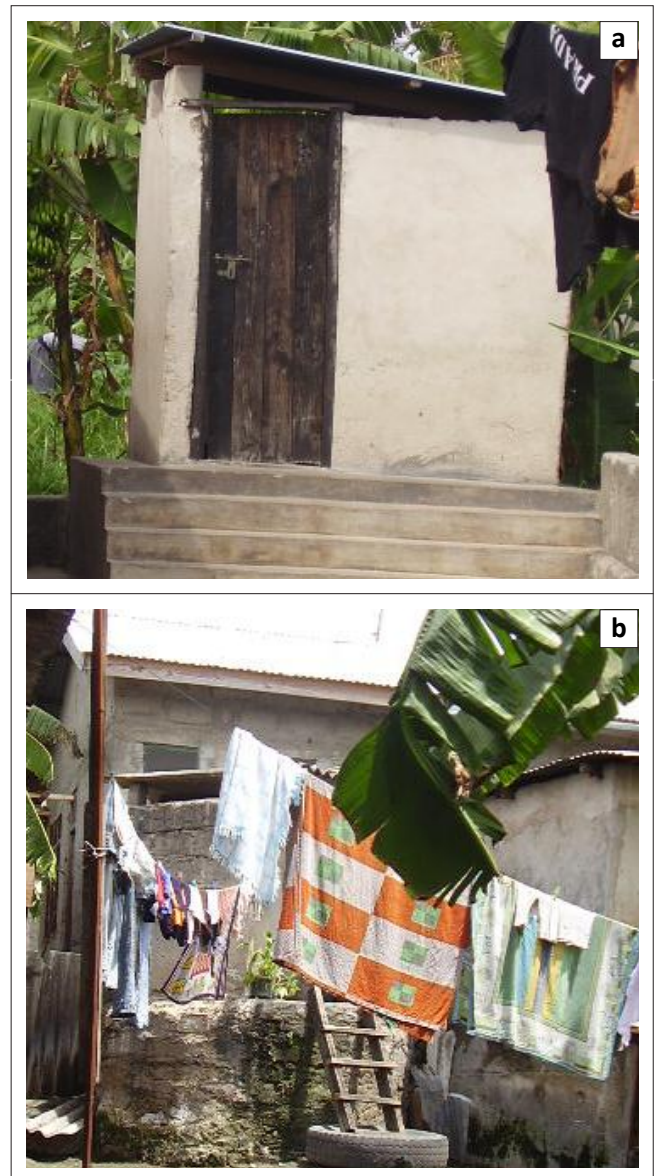
**FIGURE 7:** (a) Pit latrines (b) raised from plinth level.

As a result of flooding and the fluctuating water table, most households raised their doorsteps and pit latrine steps to prevent the stormwater from filling up their houses and pit latrines. Of 30 interviewed households, 15 had raised doorsteps to their houses and 14 had their pit latrines raised one metre above the plinth level. It was, however, noted that this strategy was also inadequate to cope with severe flooding (see Figure 7).

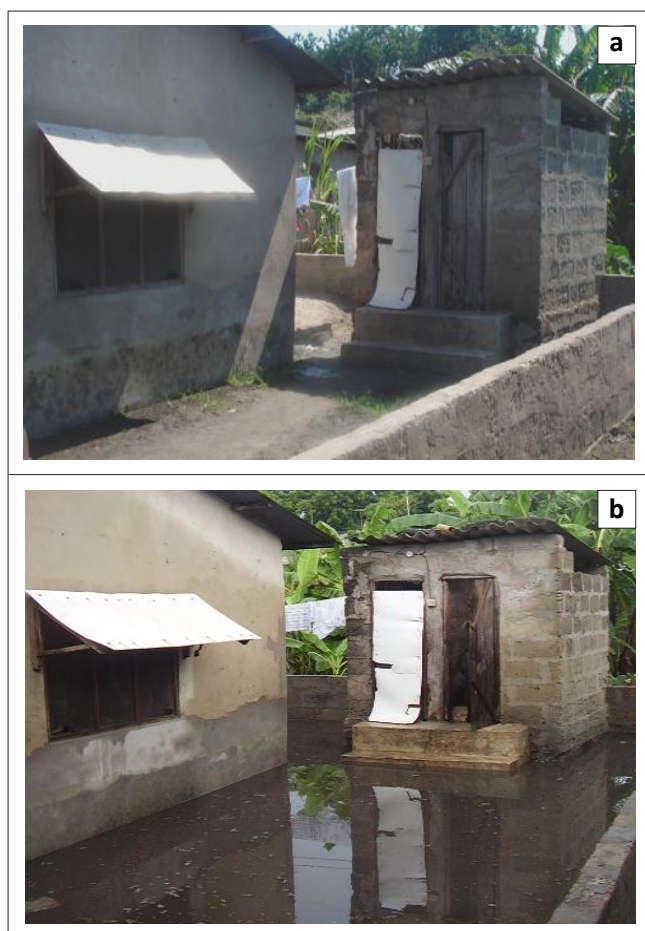
**FIGURE 8:** Construction of protective walls (a) before rainfall and (b) after rainfall.

Wherever households had extra space around their houses, they built protective walls. Other households raised the foundation levels to prevent water from entering their houses. Although this solution helped individual houses, it largely blocked water flow during flooding. Also erosion caused some of the protective walls and houses to fall down. Protective walls were used by few households – only 6 out of the 30 interviewed. Since protective walls were constructed around the whole house flood water remained within the house compounds for long periods of time, resulting in other damage such as erosion of the foundations of buildings (see Figure 8).

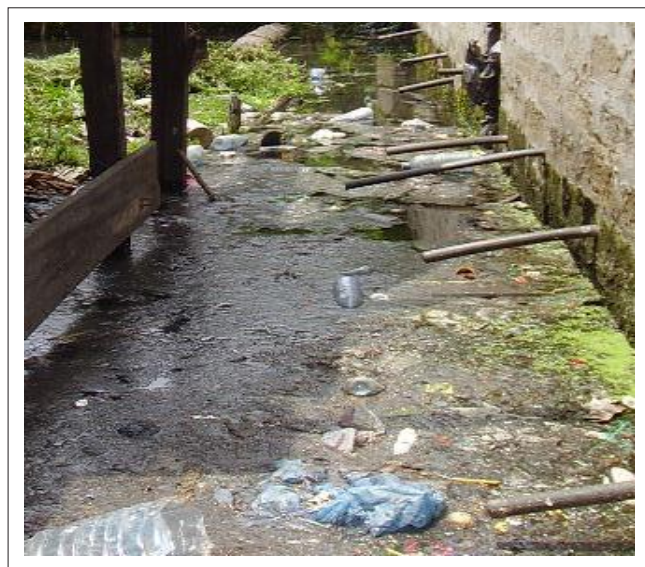
**FIGURE 9:** Outlet pipes.

Water outlet pipes were built above the plinth level to drain off water. The most common pipes were of 20 mm – 50 mm in diameter. These outlets reduced water to a certain extent, because during heavy rainfalls water entered houses through doors and other wall openings (see Figure 9). Only one household out of 30 used this particular strategy.
