Using geographic information system to evaluate land use and land cover affected by flooding in Adamawa State, Nigeria

Musa, S.D. & Shabu, T.S., 2019, 'Using geographic information system to evaluate land use and land cover affected by flooding in Adamawa State, Nigeria', *Jàmbá: Journal of Disaster Risk Studies* 11(1), a494. <https://doi.org/10.4102/jamba.v11i1.494>

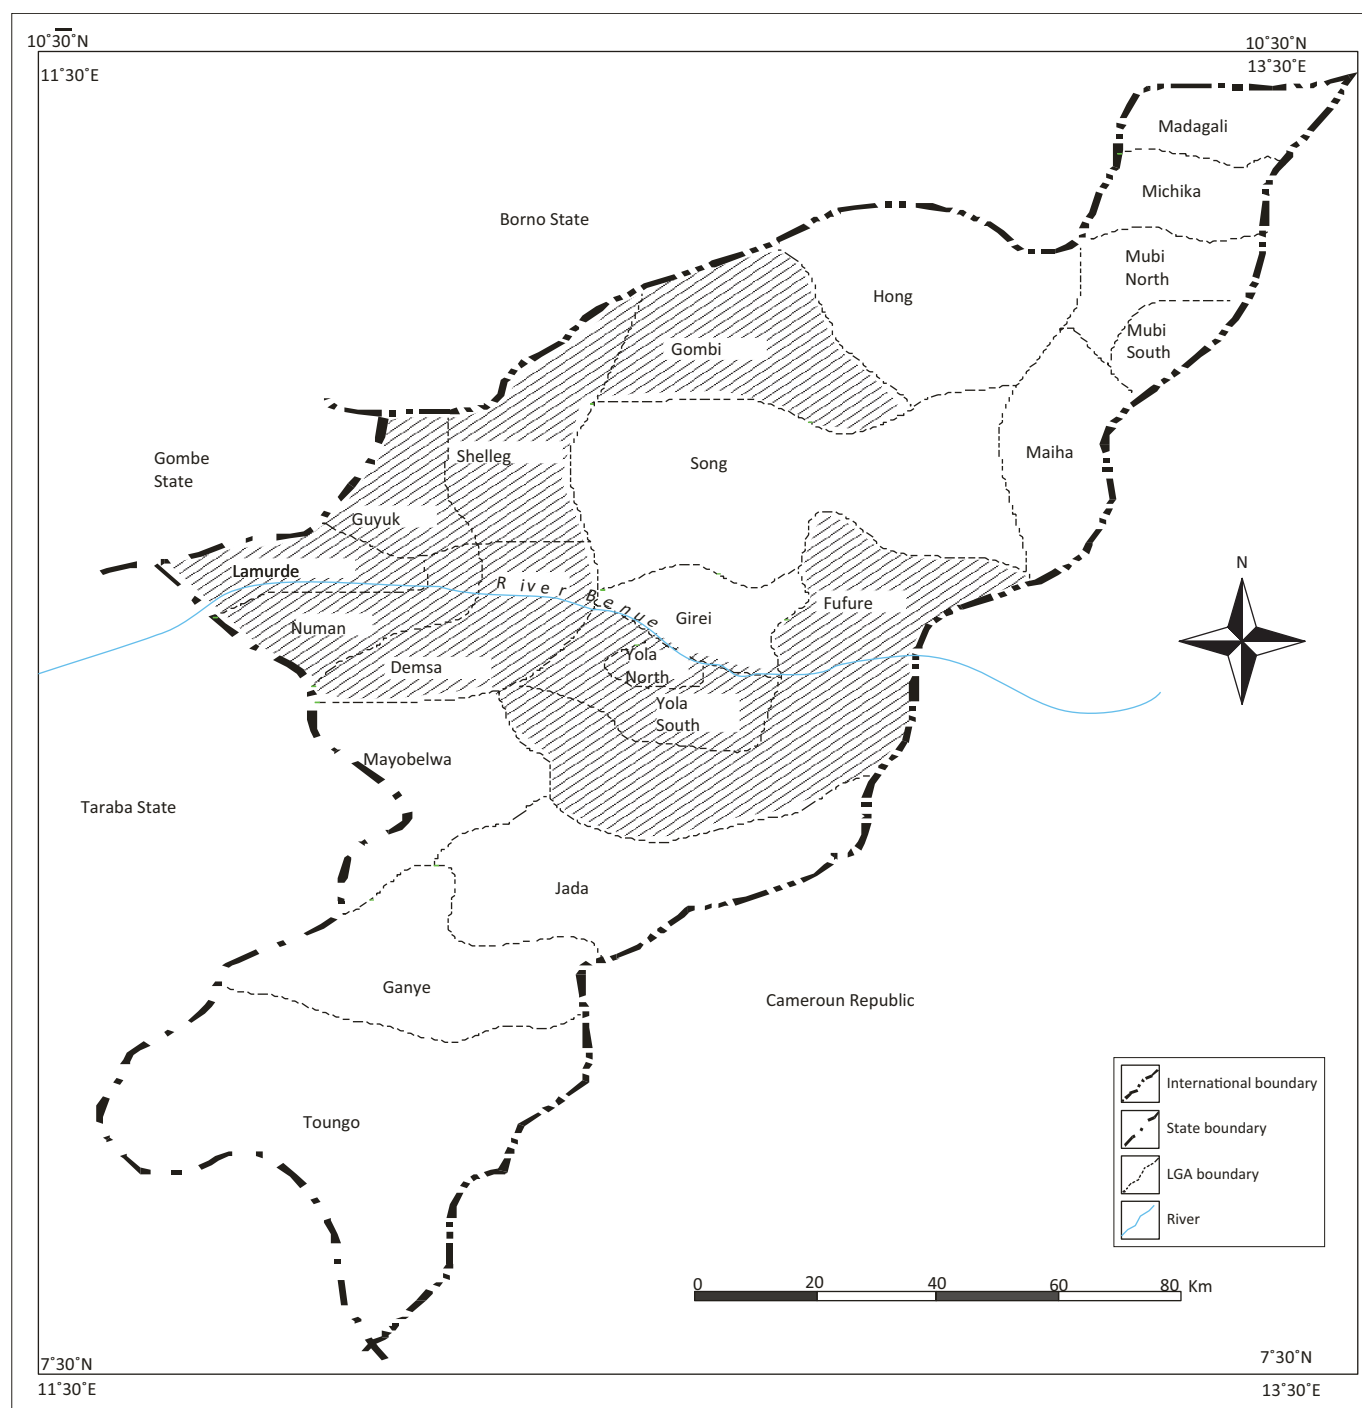
FIGURE 1: Adamawa State showing the study area.

Two factors were considered in modelling the inundated areas in the study area (see Figure 1): proximity to the Benue

The flooded LGAs in the Adamawa area includes Demsa, Fufore, Girei, Lamurde, Numan, Shelleng, Song, Yola north and Yola south (Figure 1). The flooded area in Adamawa State is about 276 089 ha. Six features, (i.e. waterbody, bareland, farmland, vegetation, alluvial deposits and settlement) of land covers of the affected LGAs, were classified based on their spectral signature. The 2002, 2012 and 2014 classified images are presented in Figures 2–4.

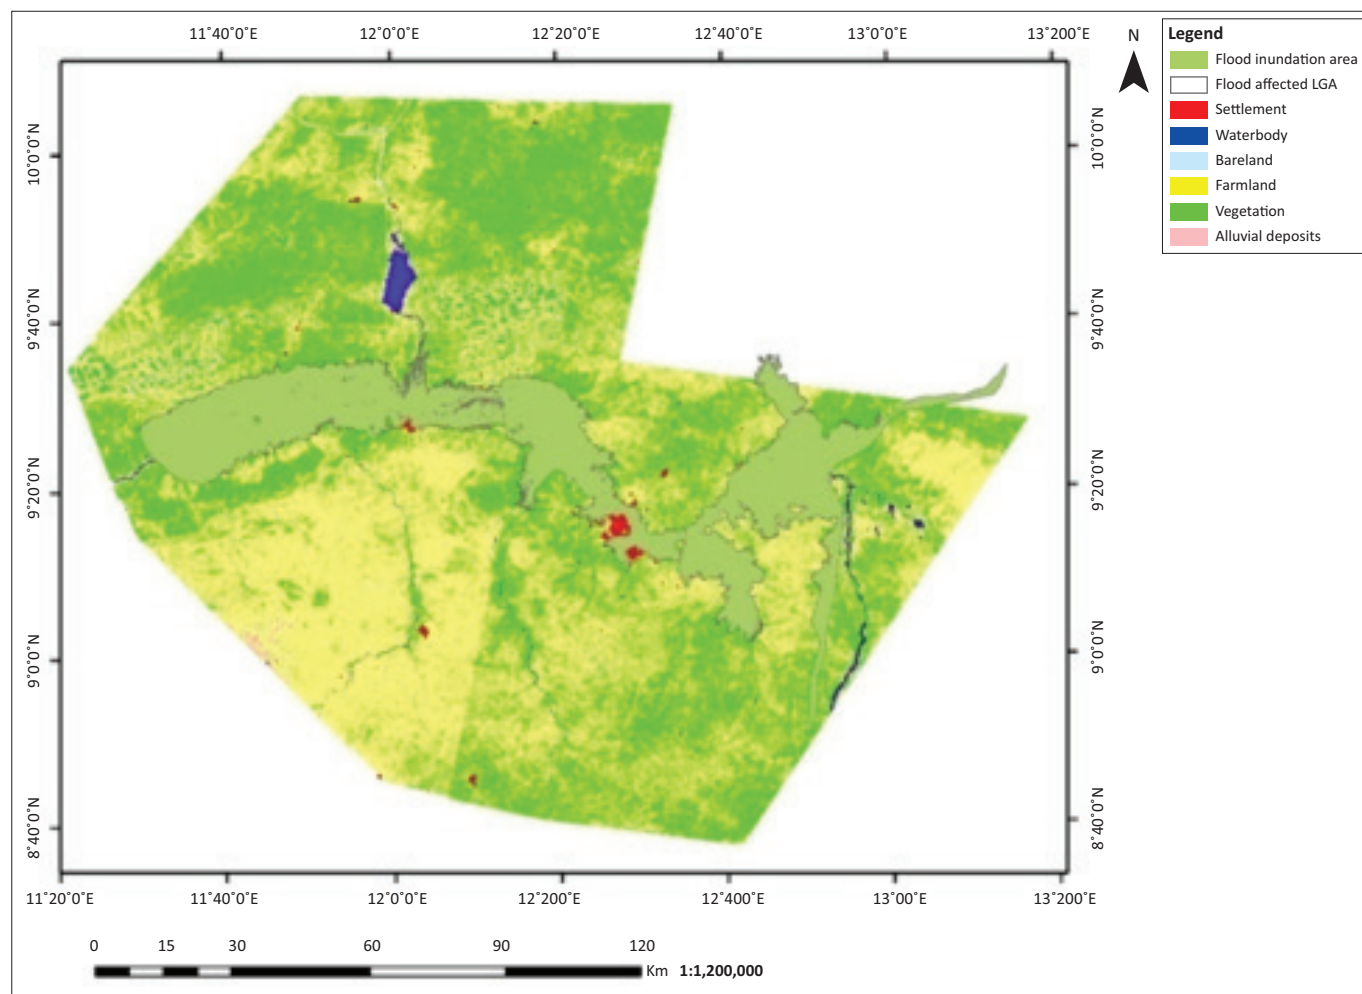
FIGURE 2: Flood inundation and land use and/or land cover of Adamawa 2002.

The flood incidence of 2002 affected 53% vegetation land cover of the area followed by 38% farmland of the total inundated areas of Adamawa State. Only 1% of settlement area was affected by flooding, whereas 6% of waterbody, especially drinking water, was affected by flood disaster (see Figure 8). Apart from 53% of vegetation cover that was affected, 38% of farmland comparing different kinds of crops, such as cereals, roots or tubers, tree crops and others, were affected by flooding of 2002. This led to some extent to food security issues within the areas affected by the flood disaster.

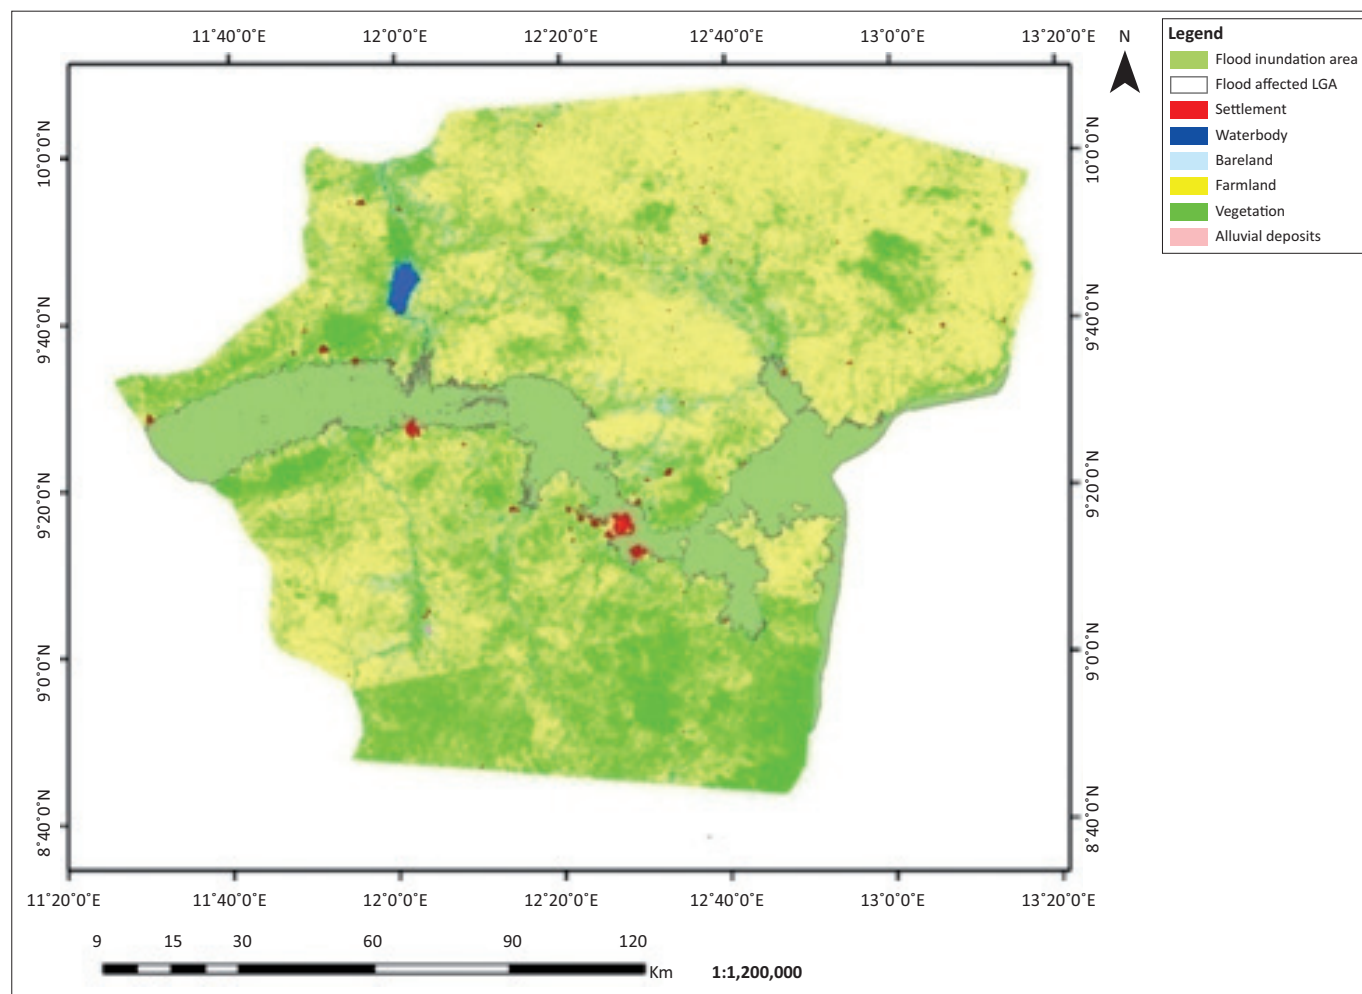
FIGURE 3: Flood inundation and land use and/or land cover map of Adamawa 2012.

The inundated areas in Adamawa State affected farmland, waterbody, vegetation and alluvial deposits. Among the land cover affected by the 2012 flooding, farmland and vegetative cover were the most affected in the area.

The flood incidence of 2012 affected 56% farmland cover of the area followed by 35% vegetation of the total inundated areas of Adamawa State. Only 2% of settlement area was affected by flooding (see Figure 9). The 2012 flooding affected more farming activities and crop production than any other economic activities. This resulted in food crises and food security issues, leading to malnutrition and diseases in the area.

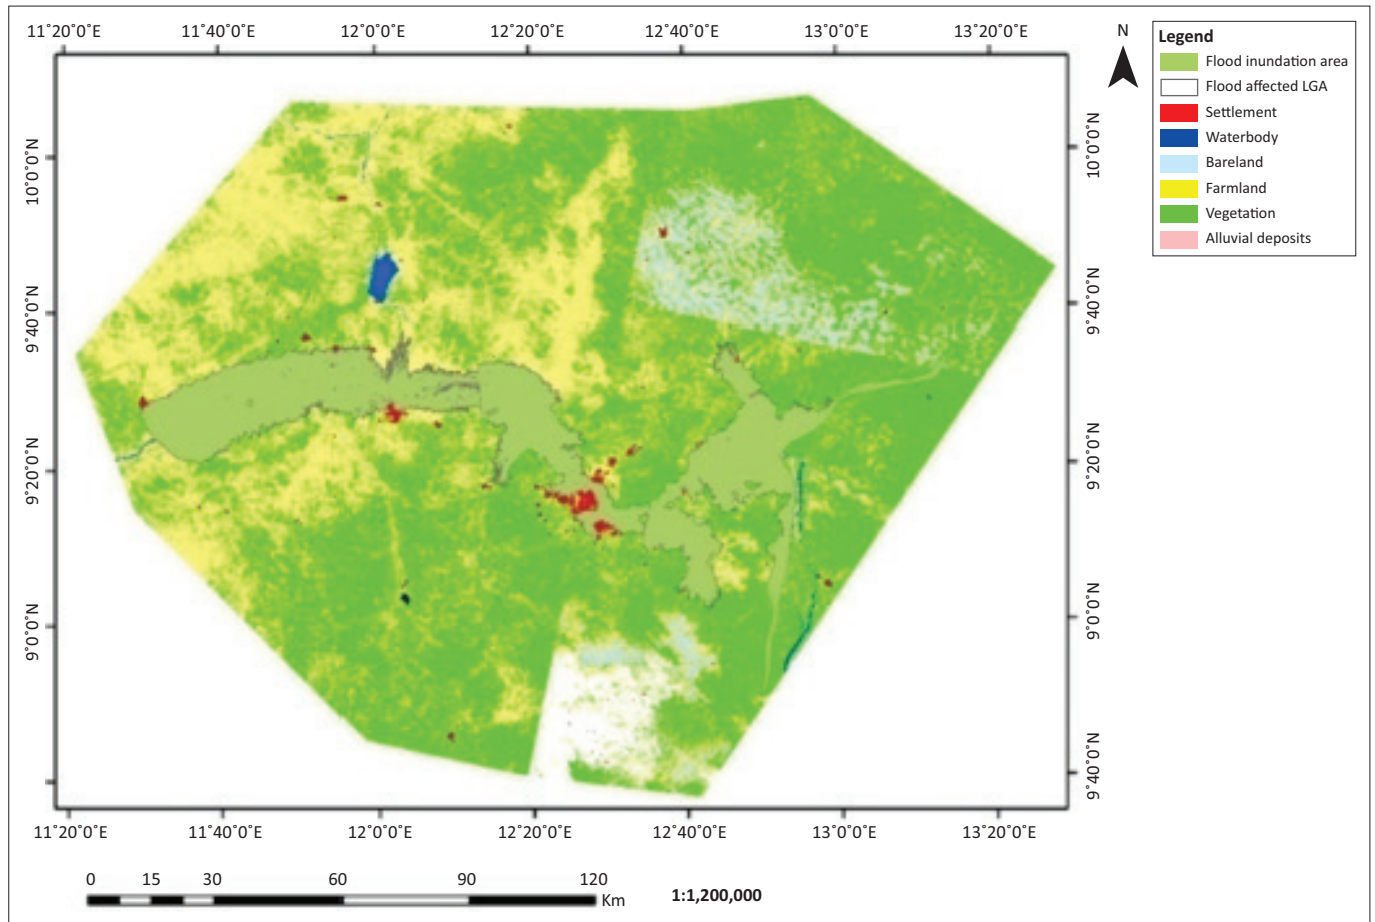
FIGURE 4: Flood inundation and land use and/or land cover map of Adamawa 2014.

The flood incidence of 2014 affected 51% farmland cover of the area followed by 42% vegetation of the total inundated areas of Adamawa State. Only 2% of settlement area was affected by flooding (see Figure 10). From estimates of land covers affected by the 2014 flooding, it was observed that 51% farmland was affected. Crops at various stages of development were submerged. Even though some of the crops regenerated after flood water resided, their output was not enough to offset losses observed during and after the flood.

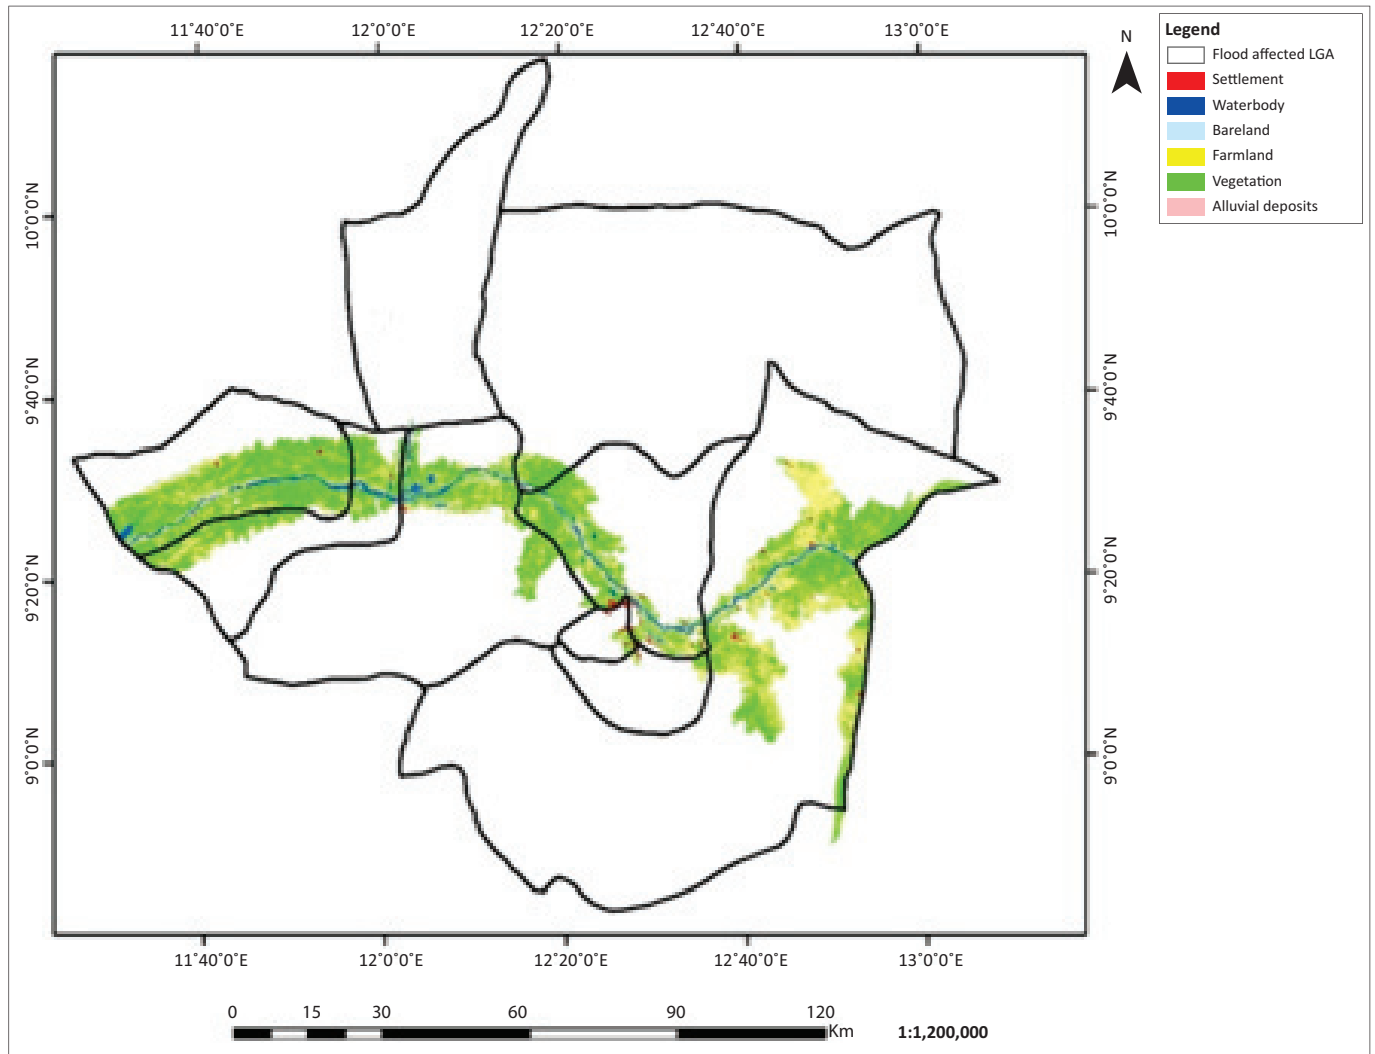
FIGURE 5: Flooded land cover and/or land use in Adamawa State in 2002.

The classified images of Adamawa covering flood inundated areas of Landsat ETM 2002, 2012 and 2014 are presented in Figures 3, 4 and 5, respectively. Six features of land cover affected by flood waters were identified and estimated. The land covers affected include waterbody, bareland, farmland, vegetation, alluvial deposits and settlement (see Table 1 and Figures 5–7).

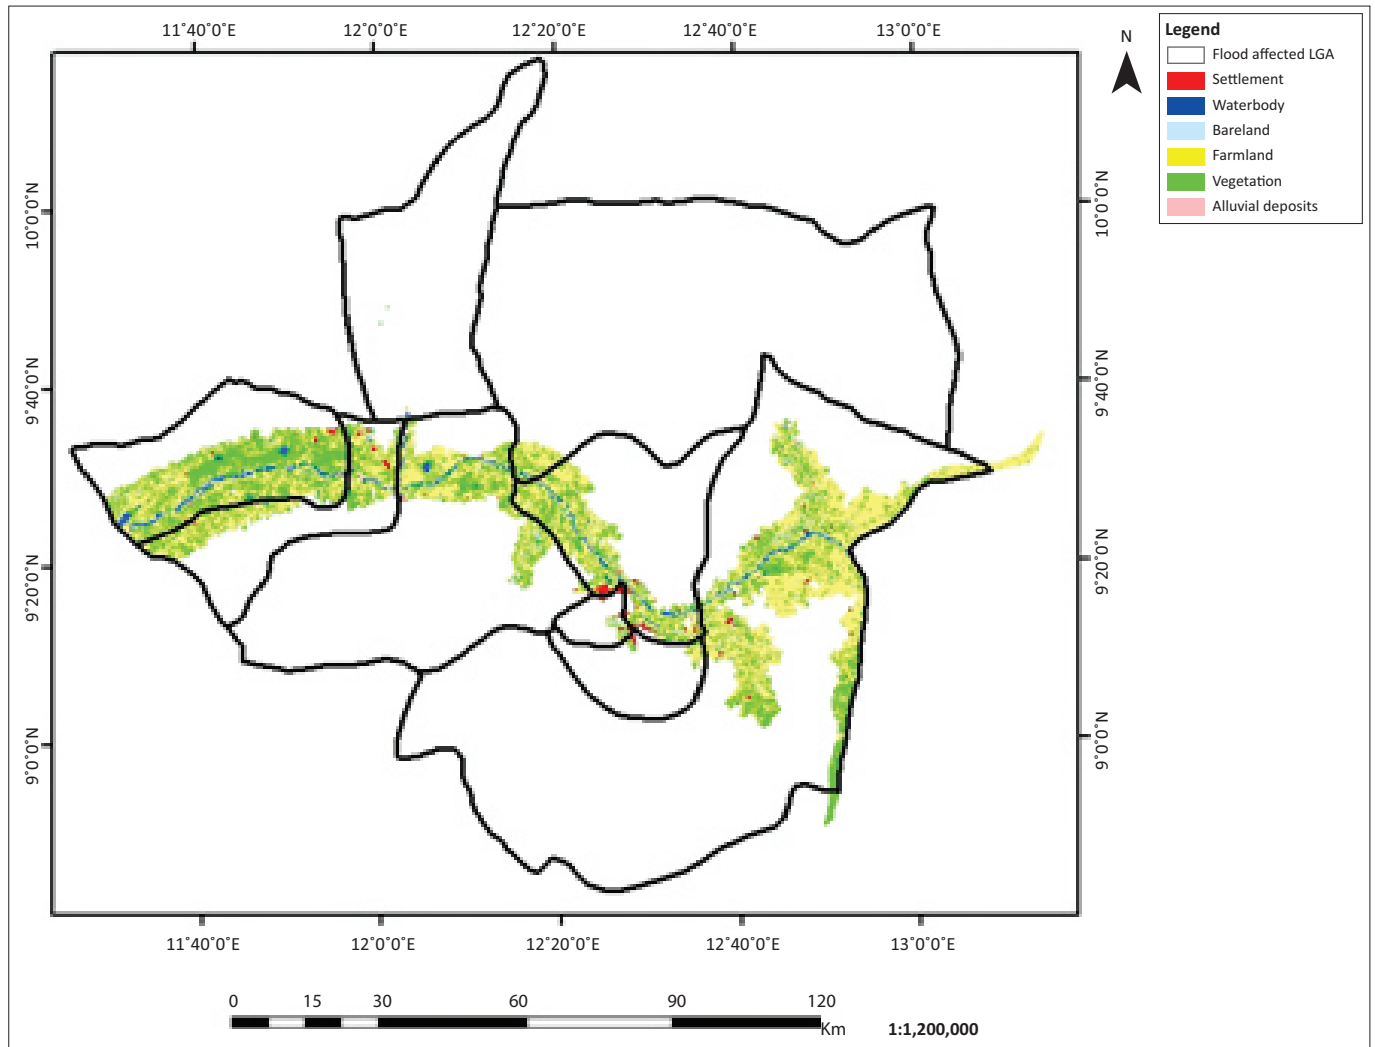
FIGURE 6: 2012 flooded land cover and/or land use in Adamawa State.

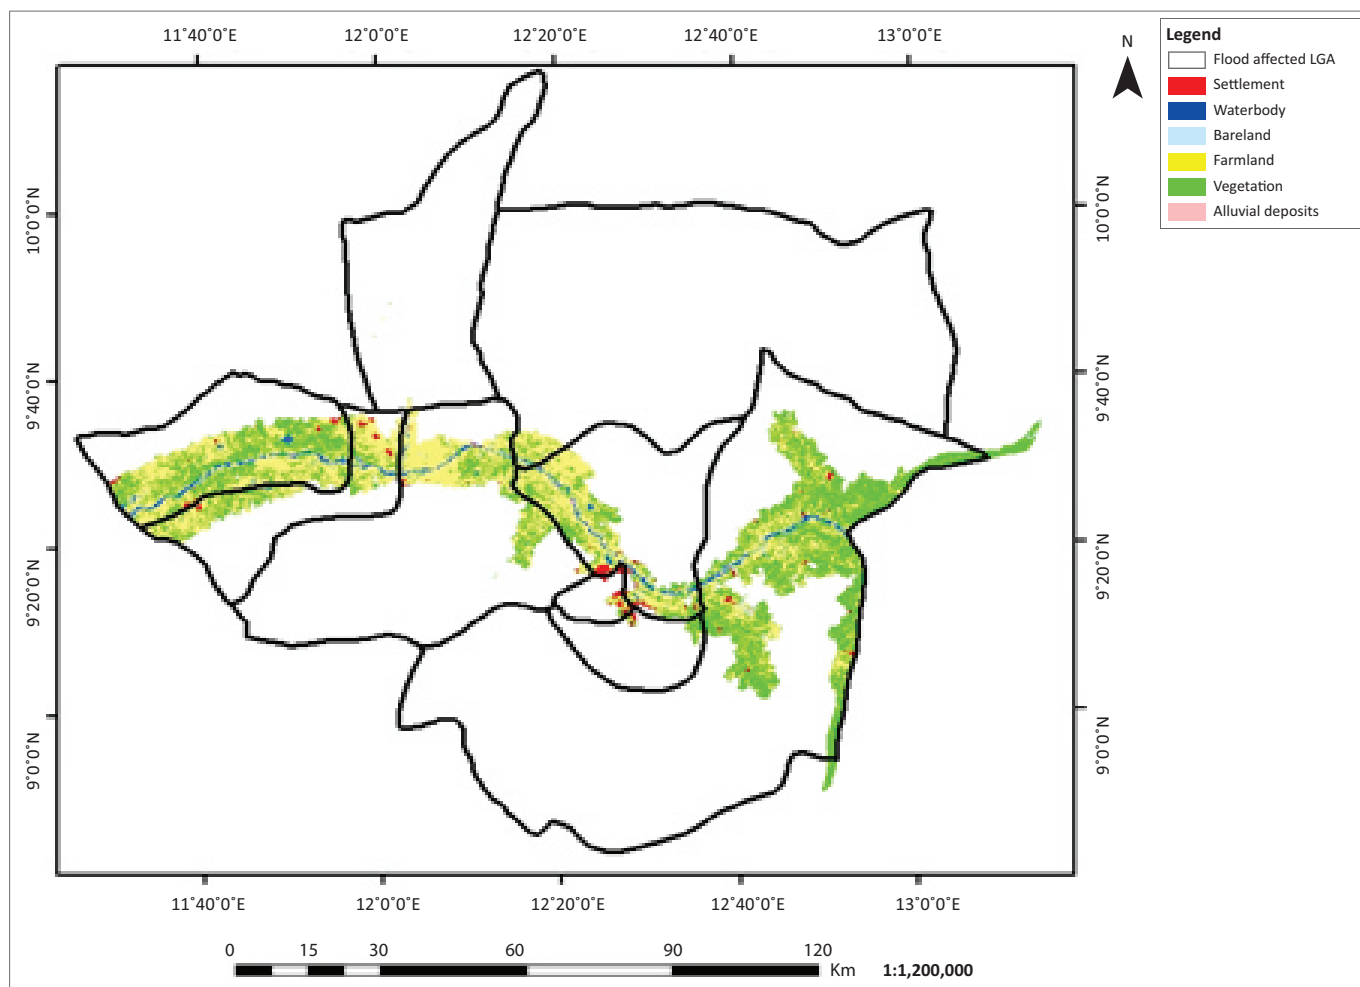
FIGURE 7: 2014 flooded Local Government Area in Adamawa State map.

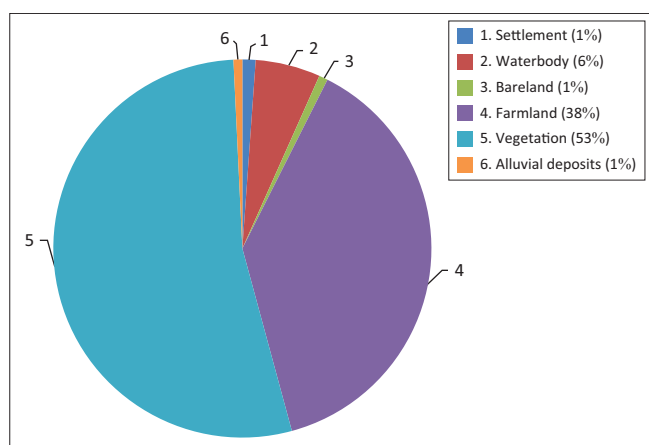
FIGURE 8: Land cover and land use affected by 2002 flooding in Adamawa.

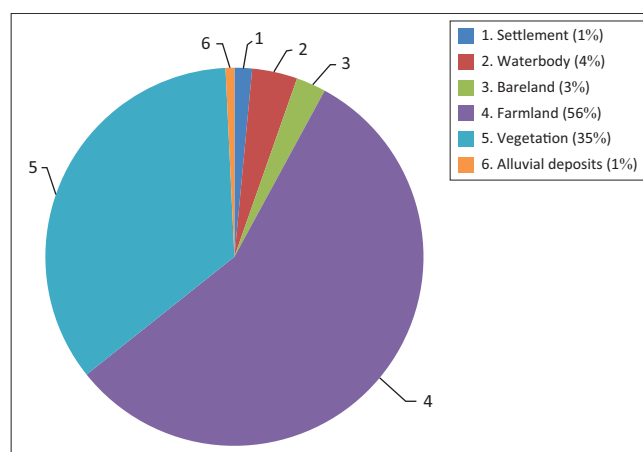
FIGURE 9: Land cover and/or land use affected by 2012 flooding in Adamawa.

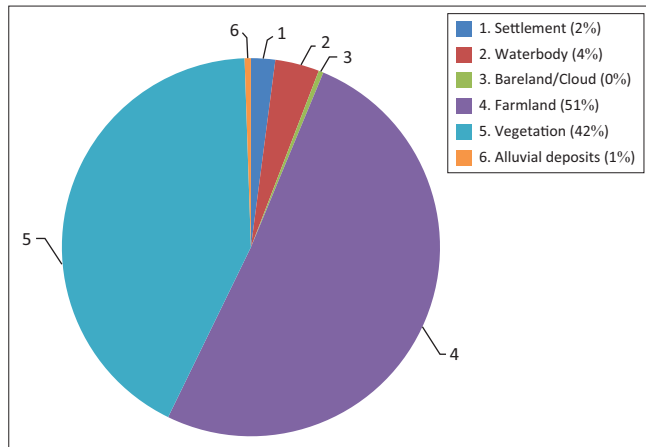
FIGURE 10: Land cover and/or land use affected by 2002 flooding in Adamawa.
