Use of Satellite Images to map Flood Extension around the city of Saint Louis in the Senegal River Estuary

Aliou Dia, Jacob Loulou Kouame, Jean-Paul Rudant and Soulèye Wade.

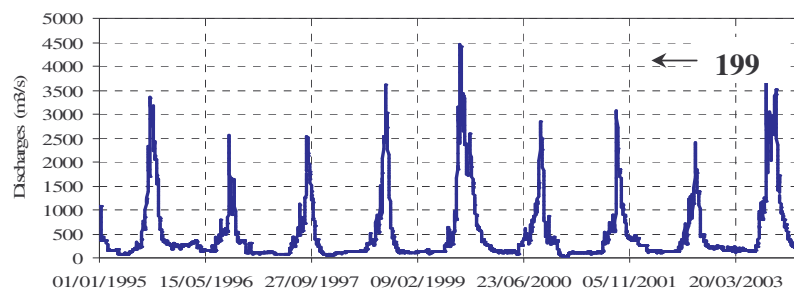
Figure 2: Time Series of Discharge at Bakel (1995-2004)

Due to exceptionally high rainfall in Fouta-Djalon in the rainy season of 1999, peak flow at Bakel was reached of $4440 \text{ m}^3/\text{s}$ (IRD¹, 2001).

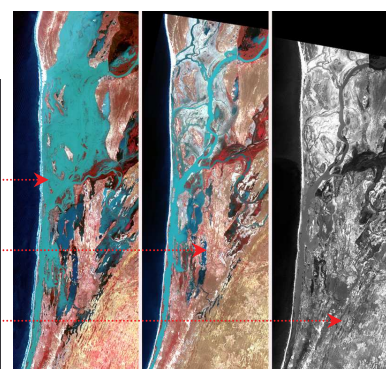
Figure 3: SPOT images

Tableau 1: Available image for this study

Date	Mode	Season	Observations
23 10 1999	XS 4	Rainy	high floods
31 10 2001	XS 4	Rainy	low floods
16 01 2002	Panchromatic	Dry	no floods

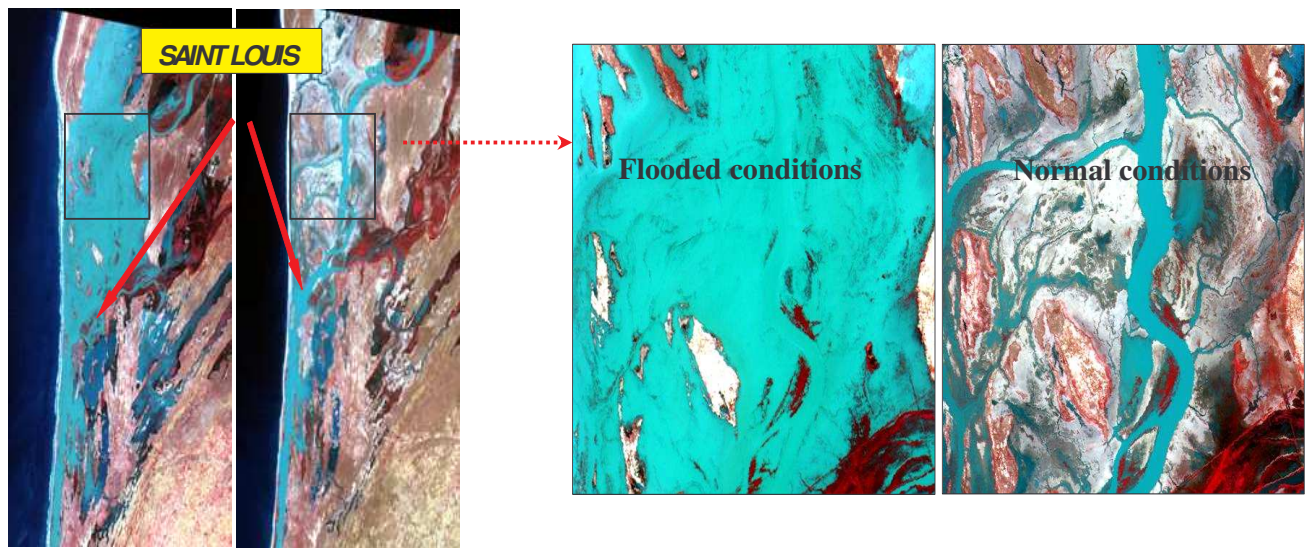
Figure 4: Satellite Imagery of Senegal River Lower Estuary, Flood conditions in October 1999 (left) and no flood conditions in October 2001 (right)

The satellite image below (figure 3) indicates the difference between the floods of 1999 and non-flood conditions. Unlike the normal floods, which cover large parts of the valley for several days or weeks during August to September 1999, the floods in 1999 lasted until mid-October in many areas, killing people and destroying roads, houses, crops, and other assets.

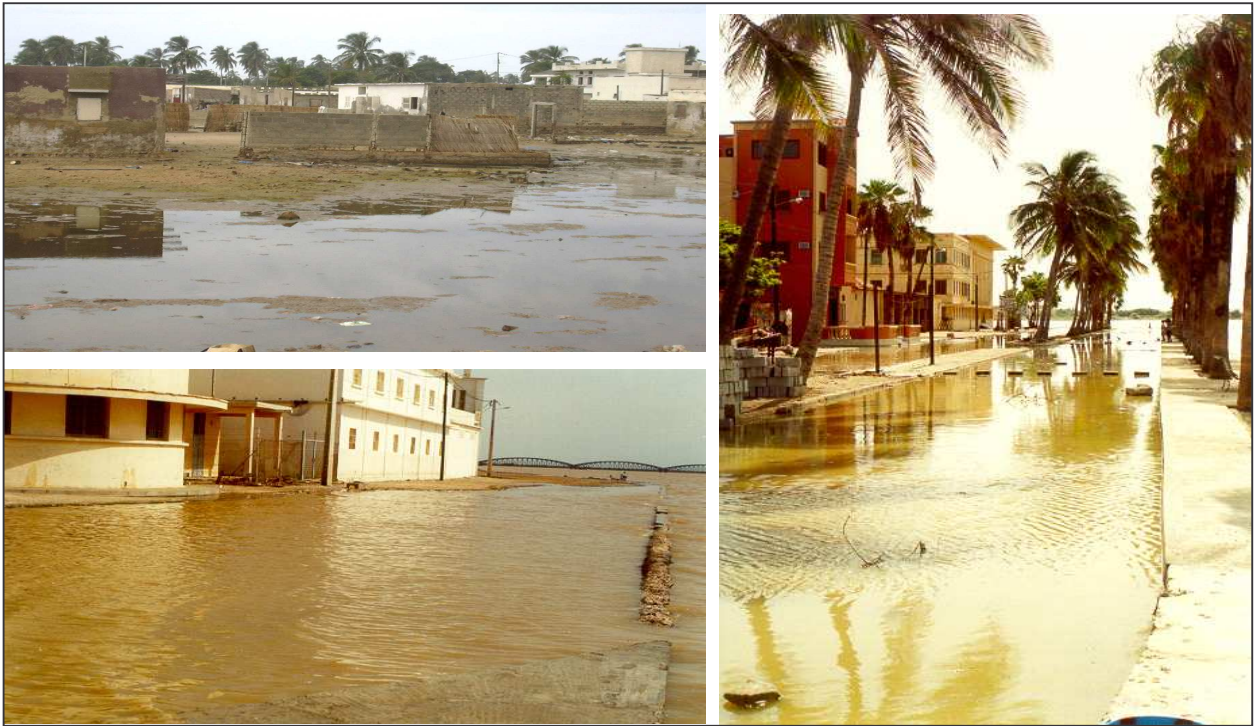
Figure 5: A view of flooded area in Saint-Louis in 1999

The impacts of the floods were severe because of the high levels of vulnerability and low levels of resilience of the population, the lack of adequate physical protection infrastructure and changing flood patterns due to environmental change as well as the impact of the Diama dam's structures. Man-made factors contributed to the seriousness of the event. The increasing occupation of floodplains around the city of Saint Louis in the estuary, competing and conflicting developmental demands in the lower Senegal river valley have exacerbated the impacts of floods on society (Dia, 2004). Even though the floods are obviously a fact of nature, their impacts on local resident depend on a large scale on the behaviour of the population.
