# Algae colonisation of brick pavement at the University of Venda: A potential slippery hazard

Munyai, T.R., Songqishe, T. & Gumbo, J.R., 2019, 'Algae colonisation of brick pavement at the University of Venda: A potential slippery hazard', *Jàmbá: Journal of Disaster Risk Studies* 11(2), a689. <https://doi.org/10.4102/jamba.v11i2.689>

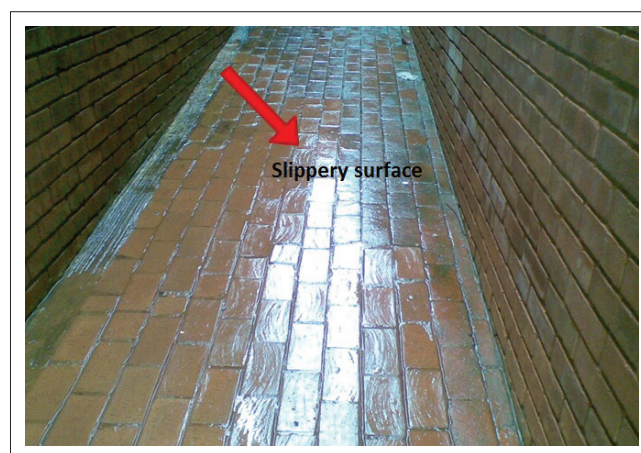
**FIGURE 1:** Algae growing on a building's wall and pavement.

The presence of algae on the pavement causes the brick surface to be slippery (Figure 1). This is hazardous because a person can easily slip and get injured. Secondly, the presence of the green colour makes the pavement unsightly to look at (the aesthetic appearance of the green colour is not attractive).

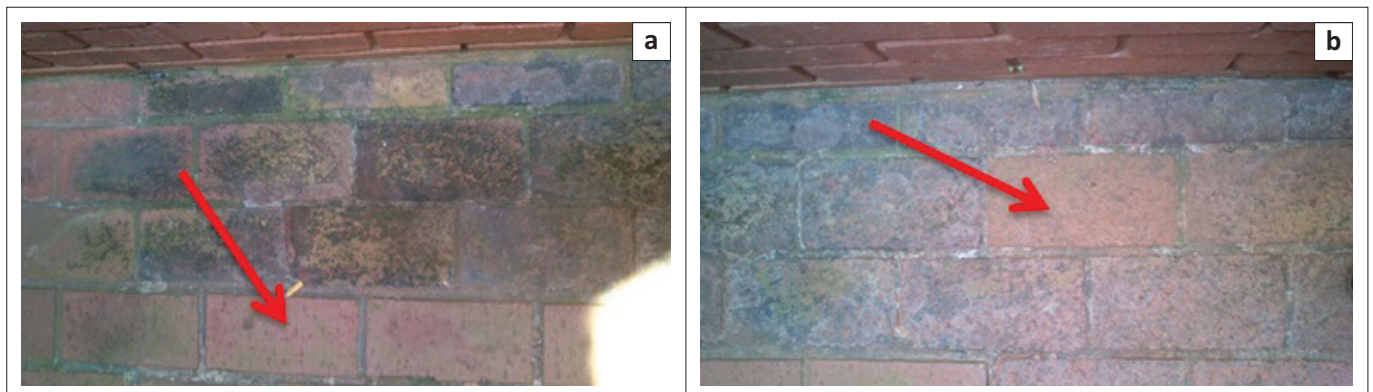
**FIGURE 4:** Some (a) pavement bricks with no presence of algae and some (b) pavement bricks with the presence of algae (pointed by red arrow).

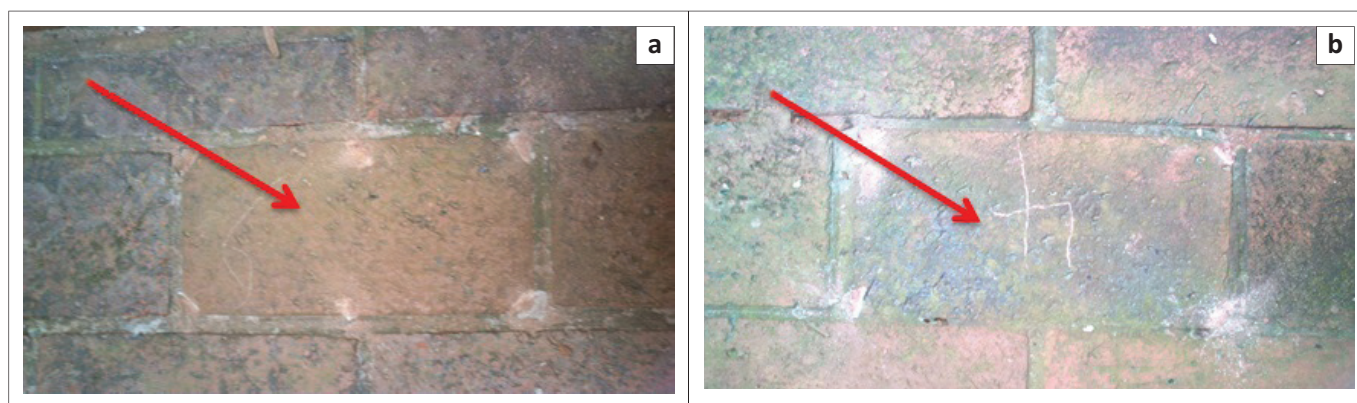
**FIGURE 5:** (a) Pavement brick with minimal presence of algae and (b) pavement brick with high levels of algae
