# An analysis of physical vulnerability to flash floods in the small mountainous watershed of Aceh Besar Regency, Aceh province, Indonesia

FIGURE 1: The Location of study – Krueng Teungku drainage watershed.

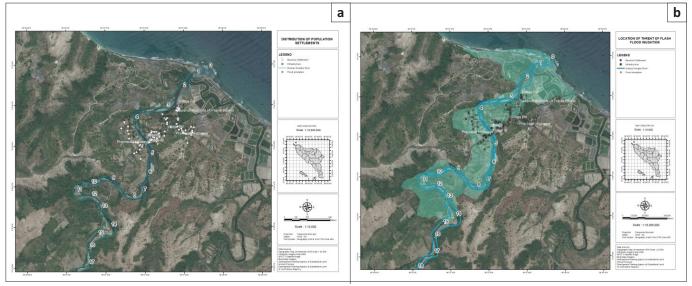
FIGURE 2: Illustration of the population and flash flood propagation. (a) Distribution of population settlements and (b) location of flash flood propagation.

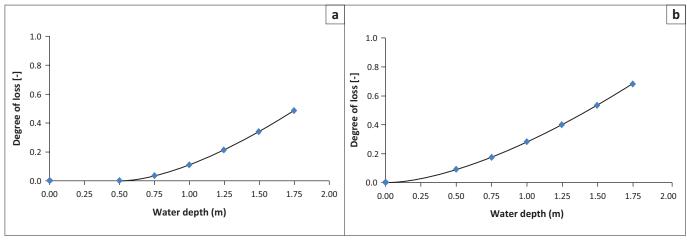
The order-3 polynomial model (M<sub>2</sub>) shows DoL is overestimated for water depths greater than 1 m. In order-2 the polynomial model represents the trend in the data more appropriately. m. meter

FIGURE 4: Results for the two different models. (a) The order-2 polynomial model (M<sub>1</sub>) and (b) the order-3 polynomial model (M<sub>2</sub>)

The order-2 Polynomial model ( $M_2$ ) shows a supposition that overestimation in DoL for water depth > 1 m. In contrast, the order-3 polynomial model ( $M_1$ ) does not demonstrate a systematic bias. As shown in Figure 4, the model  $M_1$  illustrated similar behaviour with respect to the distribution pattern of the data on models  $M_1$  and  $M_2$ . The characteristic of overestimation of model  $M_2$  produces a higher RMSE distribution and a higher variance. The differences between  $M_1$  and  $M_2$  models are shown in the boxplots in Figure 5.
